## MR YORK'S REPORT.

THE CHOLERA INQUIRY COMMITTEE, APPOINTED BY ST. JAMES'S VESTRY, having been engaged several months in investigating any causes which might have existed in the autumn of 1854 to induce the propagation of Cholera, among which was the possibility of contamination of well water from defective house drainage, the Secretary was instructed to adopt the best measures for inquiring into, and reporting upon, the condition of the drainage at the house No. 40, Broad Street, it being immediately adjoining the parish pump in that street, which examination having been made at the close of April 1855, the following were found to be the results of his investigations:—

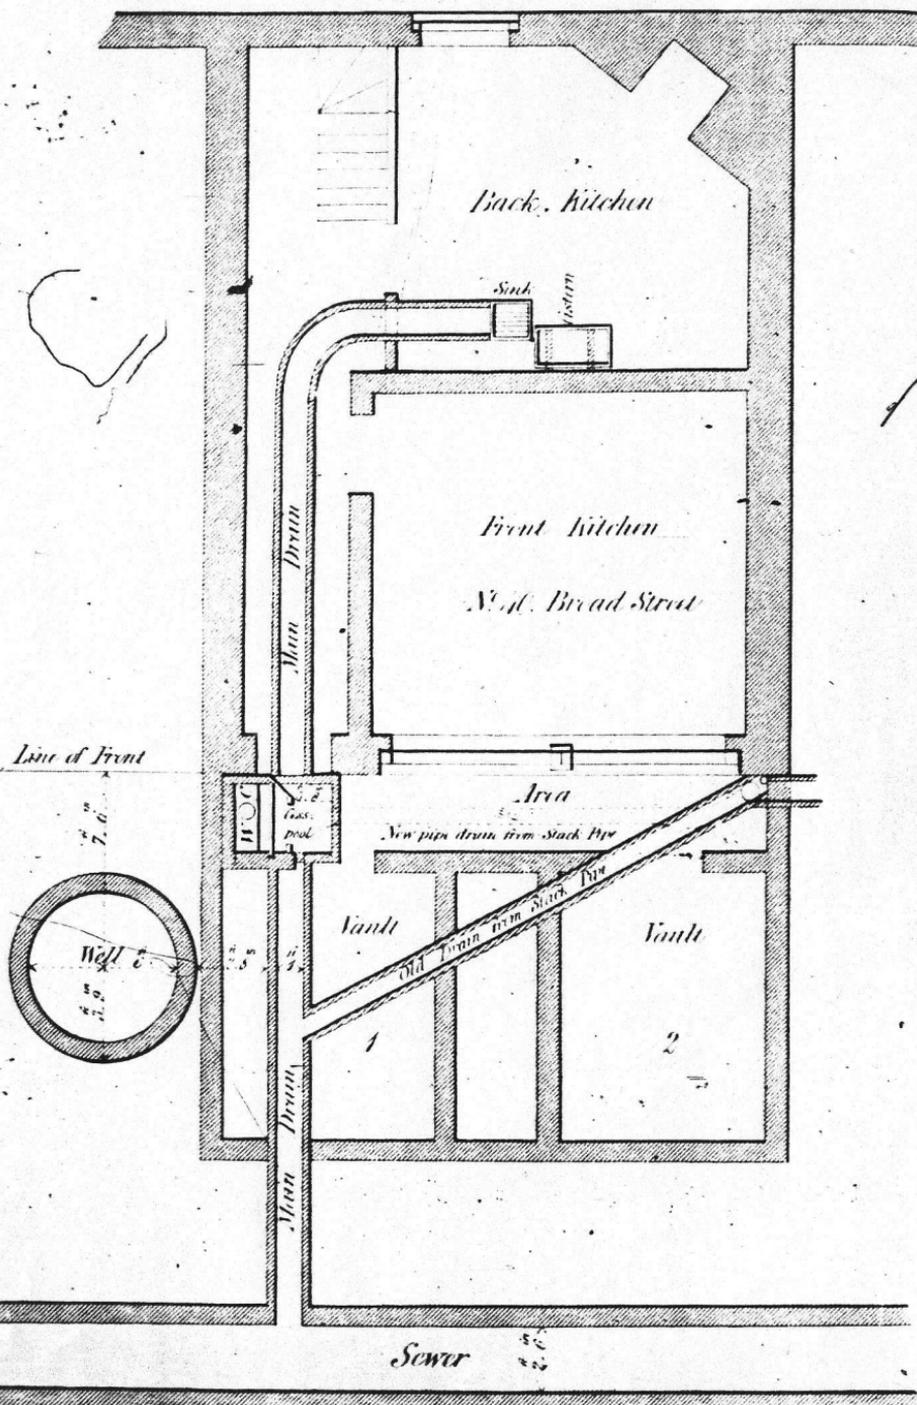
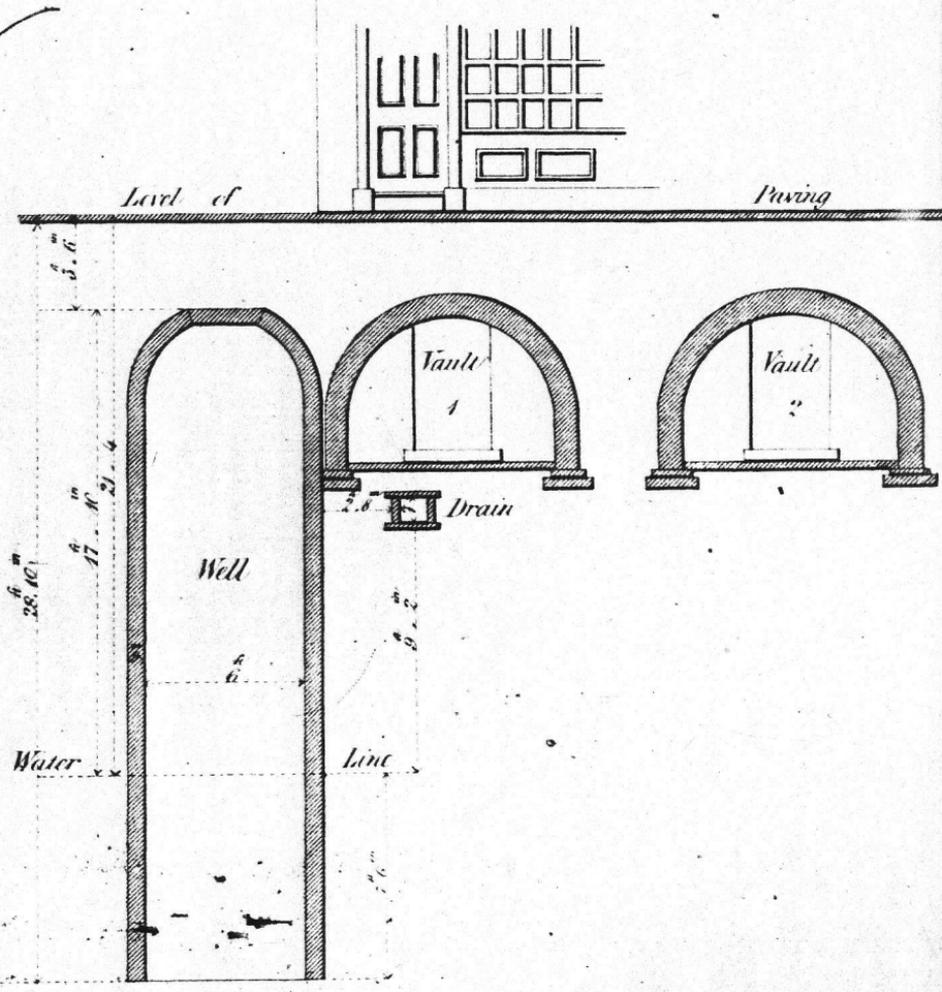
The main drain of the house was opened in the front vault under the street, and was found to be constructed on the old fashioned plan of a flat bottom, 12 inches wide, with brick sides, rising about twelve inches high and covered with old stone. As this drain had but a small fall, or inclination outwards to the main sewer, the bottom was covered with an accumulation of soil deposit about two inches thick, and upon clearing this soil away

the mortar joints of the old stone bottom were found to be perished, as was also all the jointing of the brick sides, which brought the brick work into the condition of a sieve, and through which the house drainage water must have percolated for a considerable period. Into this drain in the middle of the vault an intersecting smaller drain ran from the front stack pipe at the south-west angle of the front area, bringing the rain water from off the roof of the house, and also forming a communication with the drains of the adjoining house westward (No. 39.)

Upon opening back the main drain, a cesspool intended for a trap, but misconstructed, was found in the area 3ft. 8in. long, by 2ft. 6in. wide, and 3ft. deep, and upon, and over a part of this cesspool a common open privy (without water supply) for the use of the house was erected, the cesspool being fully charged with soil. This privy is formed across the east end of the area, and upon removing the soil the brickwork of the cesspool was found to be in the same decayed condition as the drain, and which may be better comprehended by stating that the bricks were easily lifted from their beds without any, the least force; so that any fluid could readily pass through the work, or as was the case when first opened, over the top course of bricks of the trap into the earth or made ground immediately under and adjoining the end wall eastward, this surface drainage being caused by the accumulation of soil

in, and the misconception of the cesspool, which was intended to prevent effluvia and vermin coming into the house from the main sewer in the street, but which in fact it facilitated rather than prevented. This point is worthy of notice, and a reference to the accompanying plan prepared by me will more fully shew its misapplication as well as demonstrate the fatal effect it would have in driving or forcing any deleterious fluid matter into the ground and parish well adjoining, by preventing its running direct into the current of the house drain.

The stone placed in and across this cesspool dipped about three inches into the fluid therein contained, and as the more solid matter became deposited in it, the fluid became reduced in proportion, and when opened on the 23rd of April, 1855, it had reached that state of solidity that hardly any passage for its egress from it was left; it had in consequence commenced to overflow between the back of it and the end wall of the area, and through any other crevice at the sides of the covering which was composed of saturated rotten boards—the condition of this cesspool covering, together with the solid matter at the bottom, led me to believe that it must have been in this state for many months, but it could not possibly have gone on much longer without total stoppage. All this old drainage has been removed; the cesspool destroyed, and new tubular pipe drains with

In connection with the question of how far any communication can exist, and has existed between this defective drainage, and the adjoining parish well which supplies the Broad Street pump, a reference to the accompanying plan and section of the well and drainage of the house will I conceive set the matter at rest.

From the bottom of the house drain down to the water line in the well, a vertical depth of 9 feet 2 inches exists, and from the side of the drain horizontally to the outer side of the brickwork of the well, there is only a space of 2 feet 8 inches, whilst the side wall of the vault adjoining the cesspool actually abuts upon it; thus, therefore, from the charged condition of the cesspool, the defective state of its brickwork, and also that of the drain, no doubt remains upon my mind that constant percolation, and for a considerable period, had been conveying fluid matter from the drains into the well; but lest any doubt should arise upon this subject hereafter, I had two spaces of the brick steining, two feet square each,

taken out of the inside of the well,—the first, thirteen feet deep, from the level of the street paving, the second eighteen feet deep, and a third was afterwards opened still lower, when the washed appearances of the ground and gravel fully corroborated the assumption. In addition thereto the ground was dug out between the cesspool and the well to three feet below the bottom of the former, and its black, saturated, swampy, condition, clearly demonstrated the fact, as did also the small furrowed appearance of the underlying gravel, observed from the inside of the well, from which the fine sand had been washed away during the process of filtration.

In conclusion, I have to state that nearly the same condition was observed in the ground between the street sewer, and the end wall of the vault through which the main drain passes outwards; I presume, therefore, it is manifest to all that, the owner and the occupier of this house had both neglected to improve its drainage by not availing themselves of the facilities afforded them for doing so by the construction and use of the new sewer carried through the western half of Broad Street in the years 1851-2.

cemented joints, and a syphon trapped closet have been substituted. The drain inside of the house which leads from the front area to the back kitchen has not been disturbed, it appears to be used only for the carrying off of waste water from a sink near the cistern, but should the street pump continue to be used hereafter, it will be necessary to have this drain reconstructed.
