## Document 30–III (Online Companion)

### Cholera Inquiry Committee: “Mr. York’s Report”<sup>1</sup>

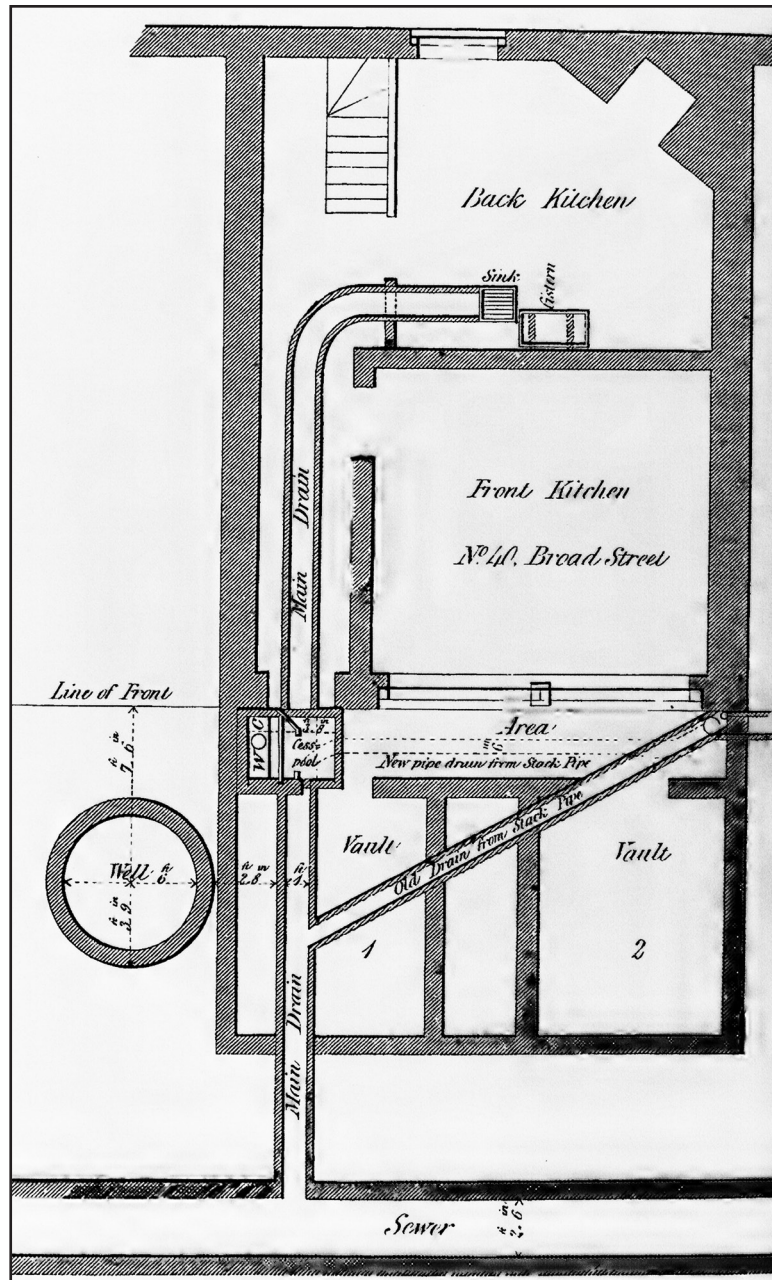
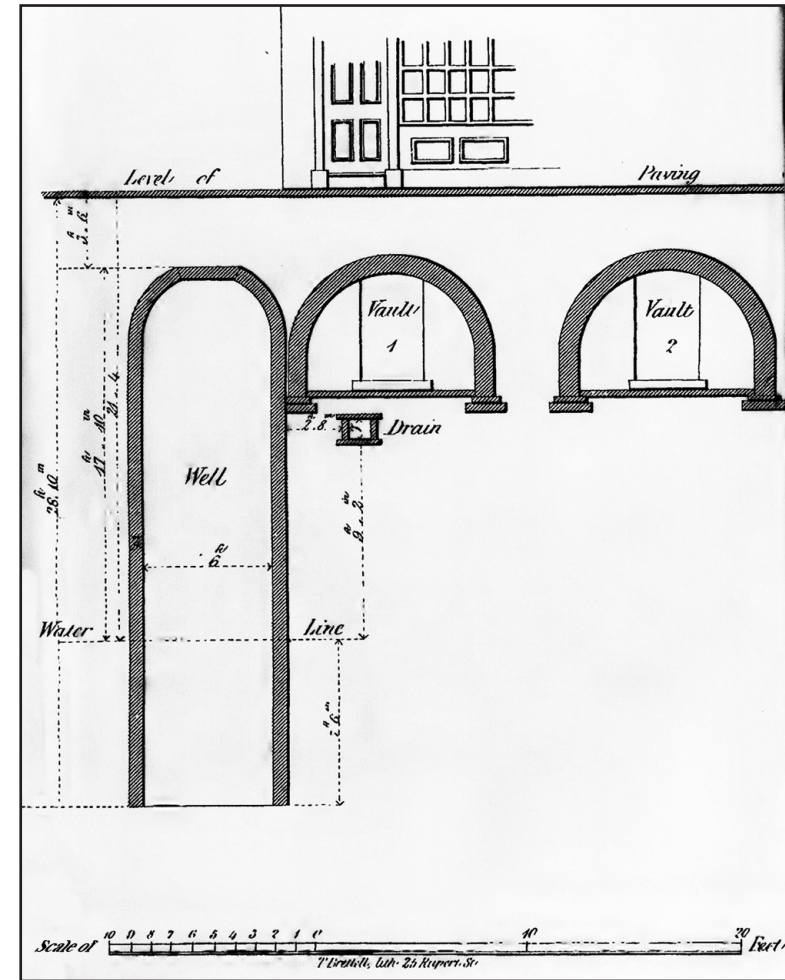
its egress from it was left. It had, in consequence, commenced to overflow between the back of it and the end wall of the area, [as well as] through any other crevice at the sides of the covering, which was composed of saturated rotten boards. The condition of this cesspool covering, together with the solid matter at the bottom, led me to believe that it must have been in this state for many months. It could not possibly have gone on much longer without total stoppage. All this old drainage has been removed. The cesspool [was] destroyed. New, tubular pipe drains with [172/173] cemented joints and a **syphon trapped** [water] closet have been substituted. The drain inside of the house which leads from the front area to the back kitchen has not been disturbed. It appears to be used only for the carrying off of waste water from a sink near the cistern. Should the street pump continue to be used hereafter, it will be necessary to have this drain reconstructed.

In connection with the question of how far any communication can exist, and has existed, between this defective drainage and the adjoining parish well which supplies the Broad Street pump, a reference to the accompanying plan and section of the well and drainage of the house will, I conceive, set the matter at rest.

From the bottom of the house drain down to the water line in the well, a vertical depth of 9 feet 2 inches exists. From the side of the drain horizontally to the outer side of the brickwork of the well, there is only a space of 2 feet 8 inches; the side wall of the vault adjoining the cesspool actually abuts upon it. Therefore, from the charged condition of the cesspool, the defective state of its brickwork and also that of the drain, no doubt remains upon my mind that constant percolation for a considerable period had been conveying fluid matter from the drains into the well. But lest any doubt should arise upon this subject hereafter, I had two spaces of the brick **steining**, two feet square each, [173/174] taken out of the inside of the well—the first, thirteen feet deep from the level of the street paving; the second, eighteen feet deep; and a third was afterwards opened, still lower. The washed appearances of the ground and gravel fully corroborated [my] assumption. In addition, the ground was dug out between the cesspool and the well to three feet below the bottom of the former. Its black, saturated, swampy condition clearly demonstrated the fact, as did the small, furrowed appearance of the underlying gravel observed from the inside of the well. The fine sand had been washed away during the process of filtration.
